# **Assessment of Photoluminescent Material During Office Occupant Evacuation**

Guyène Proulx, Ph.D. and Dale Tiller Ph.D., [Institute for Research in Construction,](#)  
[National Research Council of Canada](#)

Internal Report No. 774

Date of issue: April 1999

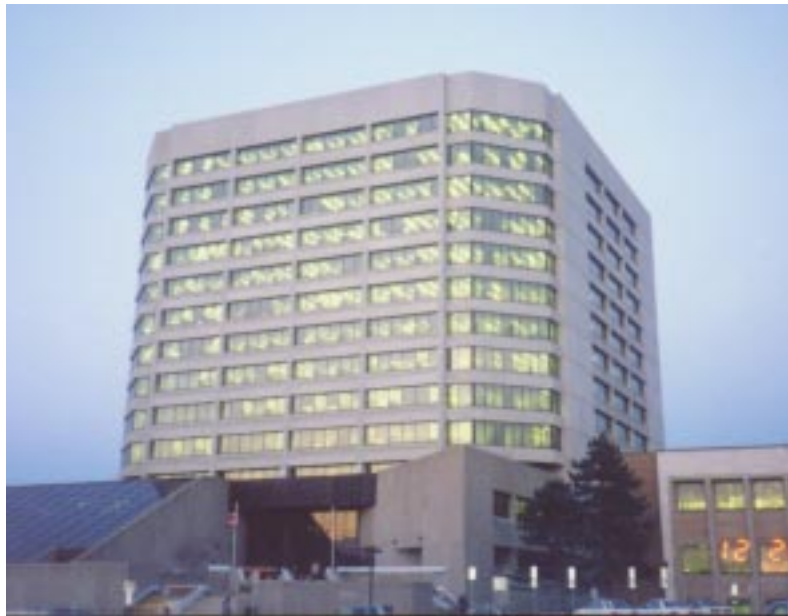
**Figure1: The Jean Talon Building**

The Jean Talon Building is a 13-story concrete structure built in 1979. The building, glazed on all sides, is almost square in shape, as presented in Figure 1. Each floor area of 3700 m<sup>2</sup> (approximately 65 m x 57 m) is an open plan concept divided into 4 quadrants, identified A, B, C and D. Work stations are divided with partition walls of 1.7 m in height. On the three floors studied (9, 10, 11), partition wall arrangements are similar. In the centre of the building is the core area, with elevators, washrooms, storage areas and a few enclosed meeting rooms. There is an average of 150 office workers on each floor doing research and clerical activities. The building has four identical windowless stairwells leading to the outside of the building. Figure 2 presents a typical floor plan of the Jean Talon building.

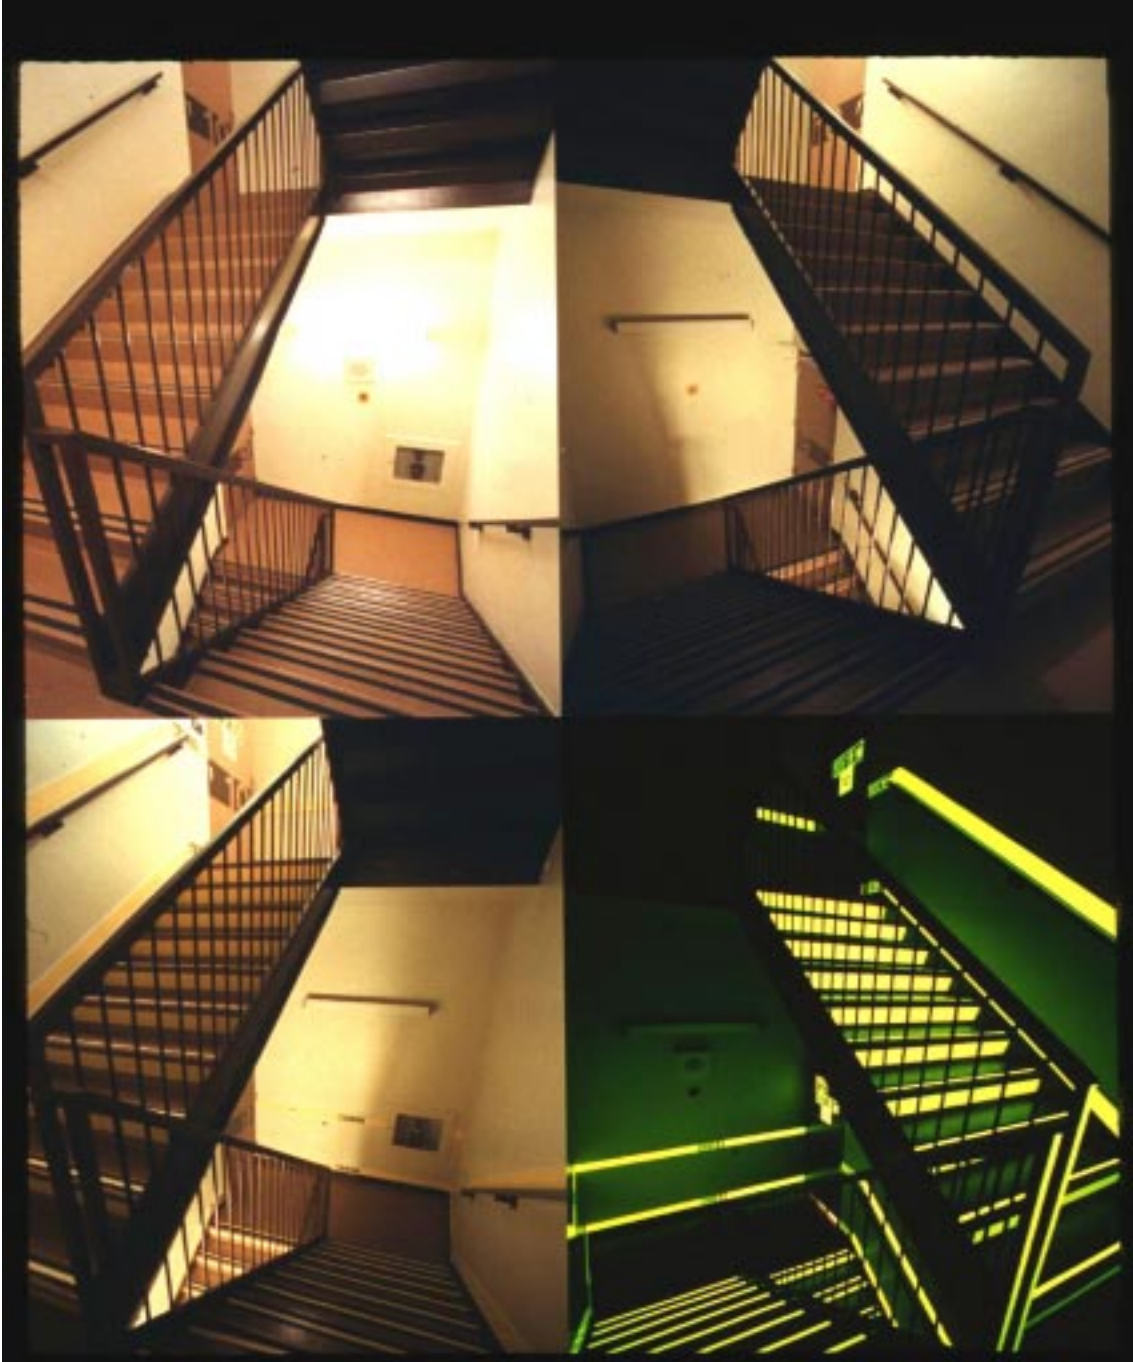
**Figure 3: Pictures of the Four Stairwells**

The picture on the upper left corner is Stairwell B with full lighting at an average of 245 lux. The picture on the upper right corner is Stairwell A with lighting reduced to 57 lux. The picture on the lower left corner is Stairwell D with PLM signs and a wayguidance system, and lighting reduced to 74 lux. The picture on the lower right corner is Stairwell C with PLM signs and a wayguidance system and no other lighting source provided.

The building's four identical stairwells presented different conditions, as shown in Table 2 and Figure 3. It is important to mention that, in this building, the stairwell emergency lighting is the full lighting with double-tube luminaires on every floor and mid-landing which provides a very well-lit stairwell of an average lighting of 245 lux. For this study, the lighting conditions in three of the stairwells were modified. Lighting in Stairwells A and D was modified to obtain a reduced output maintained above the COSH [19] requirements of an average of 10 lux and not less than 3.3 lux. To obtain this reduced output, 2 out of 3 double-tube luminaires were switched off in Stairwells A and D. With this design, Stairwell A had an average lighting of 57 lux and Stairwell D had an average lighting, slightly higher, of 74 lux. Stairwell D also had PLM signs and a wayguidance system installed. A few minutes before the evacuation, all lights were switched off in Stairwell C which had PLM signs and wayguidance system. Finally, Stairwell B received no treatment; it acted as the control stairwell.

Two of the four stairwells were equipped with PLM from the top floor of the building down to the bottom. The installation of the material was according to the PSPA Standard 002 Part 1 1997 [21], and safety signs according to BS 5499 Part 1 1990. As shown in Figure 3, the stairwell was equipped with two continuous wayguidance lines of 10 cm in width. One line was at the skirting board and the other 1 m from the floor. Directional signs were enclosed within these continuous lines. A 2 cm strip of PLM was fixed on the tread of each step and a 10 cm piece was positioned on the riser of each step. A sign identifying the floor number was installed on each door as well as a sign identifying the "Transfer Floors" on Floors 4, 9 and 13. Directional signs were positioned on each door and at mid-landing at 1.7 m from the floor. In accordance with Canadian practice, signs were positioned at the top of each exit door, identifying them as final exit. The material and installation costs for the stairwells were estimated at \$2500/floor.

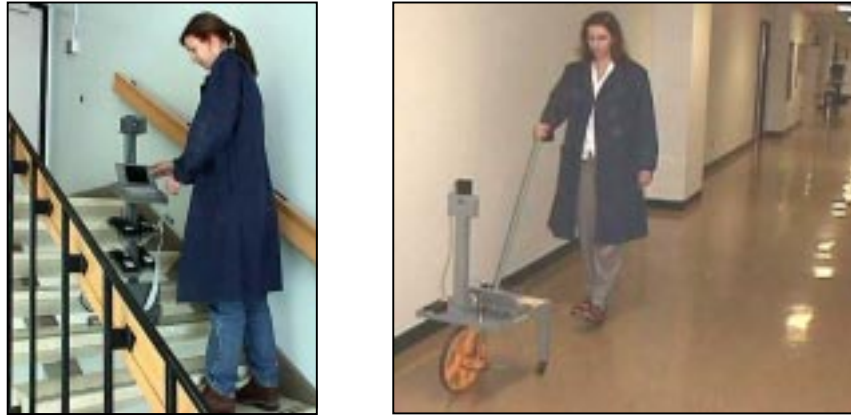
**Figure 4: Data Acquisition in Stairwells**

The picture on the left shows the configuration used in the stairwells (the stairwell depicted was not one measured in this study). The illuminance meters are mounted on a pillar such that the plane of the detectors is 1 m above the stair tread. The operator manually directs the software and data acquisition hardware mounted on the laptop computer to poll the illuminance meter, and store the measured values on the computer hard disk. Once the polling operation has been completed, the operator moves the apparatus to the next measurement location, and repeats the operation. The picture on the right shows the configuration used to collect measurements on the floors. The operator pushes the device along the centreline of the measurement path. As the calibrated wheel (circumference 1 m) turns, the data acquisition system is directed to poll the illuminance meters and store the resulting value in the computer once every 25 cm of travel.

Light levels were measured on the building floors and in the stairwells 1 m above floor level using recently calibrated Minolta T-1M illuminance meters. The meters were connected to an automated data acquisition system presented in Figure 4, which polled the meters and stored the resulting readings on a computer hard disk.

On Floors 9, 10 and 11, the operator pushed the measuring system along the centreline of the measurement path using a specially designed cart, presented in Figure 4. The operator walked the automated data acquisition system down the centreline of every path available to the occupants of these floors, following COSH recommendations (6.10.1.B) [19]. In accordance with IESNA [27] recommendations, measurements on the building floors were collected at night (IESNA, 1993, p. 60). Summary statistics describing illuminance measurements are presented in Table 4 and Figures 5 and 6.

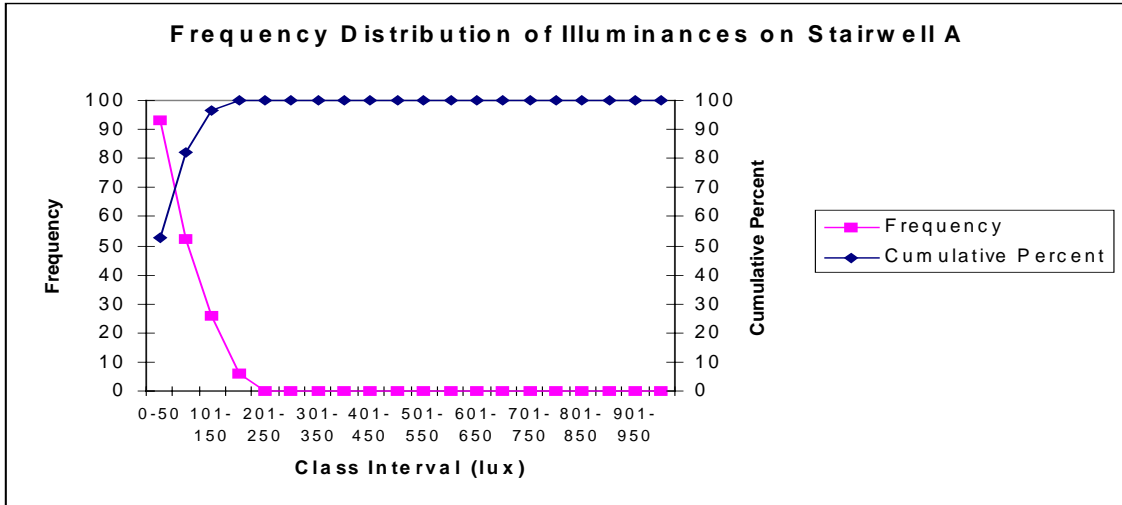
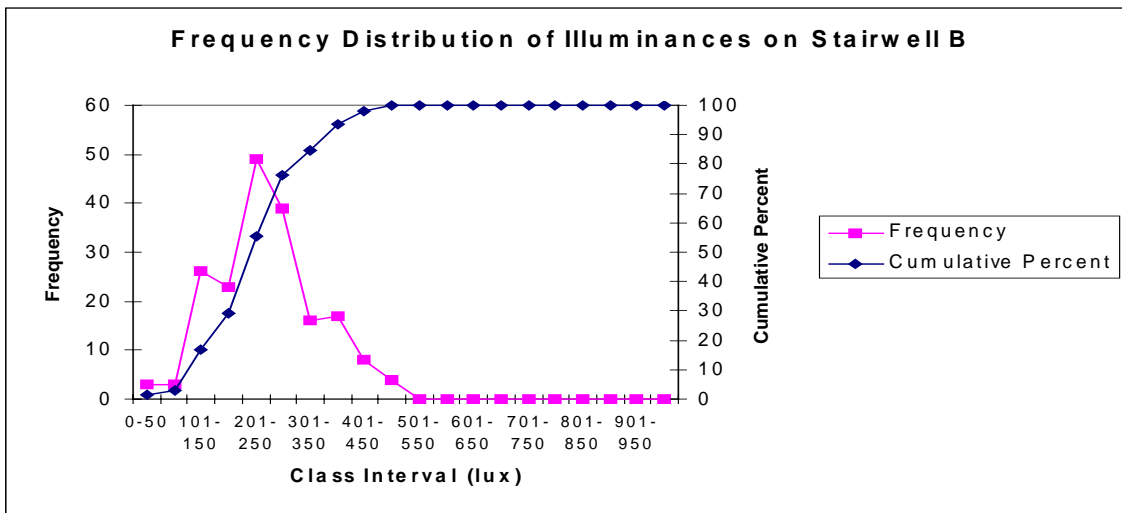
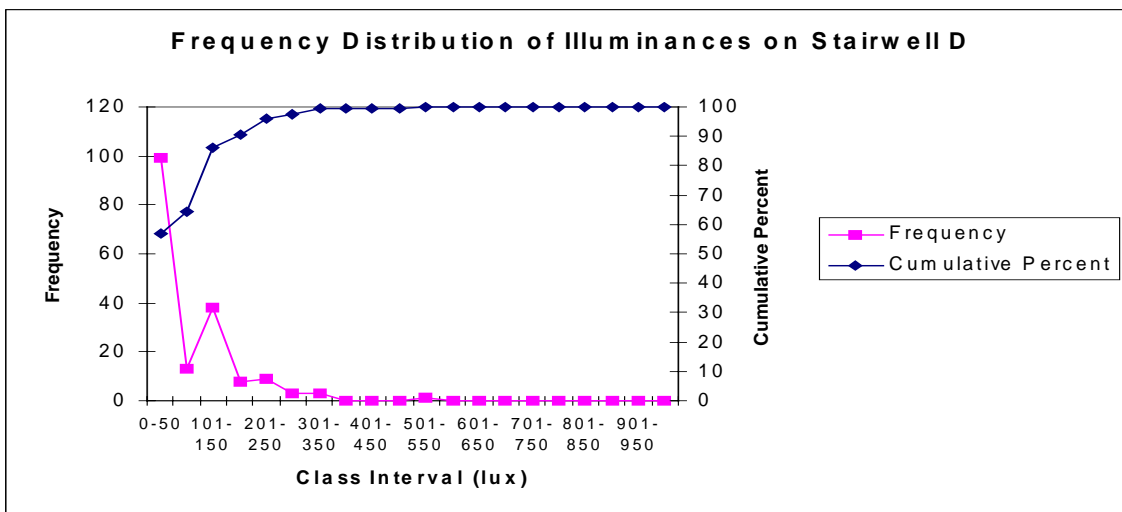
**Figure 5: Frequency and Illuminance Distributions in Stairwells**

As expected, light levels were higher in Stairwell B, which remained unmodified, than in either Stairwells A or D, where the lighting had been modified to reduce the ambient levels that would have been provided normally.

COSH [19] emergency lighting requirements specify an average level of 10 lux (6.10.2.B), with a minimum of not less than one third the average (i.e., 3.3 lux (6.11.1)). In all cases, the average requirement of at least 10 lux was achieved. Emergency lighting in Stairwells A and B met this criterion, but the emergency lighting provided on the 9<sup>th</sup>, 10<sup>th</sup> and 11<sup>th</sup> floors, and in Stairwell D, did not meet the minimum requirement of at least 3.3 lux.
